**Technology Final Report  
and  
Joint Test Report**

**Tri-Service Dem/Val of the Pulsed Optical Energy Decoating  
(FLASHJET<sup>0</sup>) Process for Military Applications**

**U.S. Army Environmental Center**

**15 March 2002**

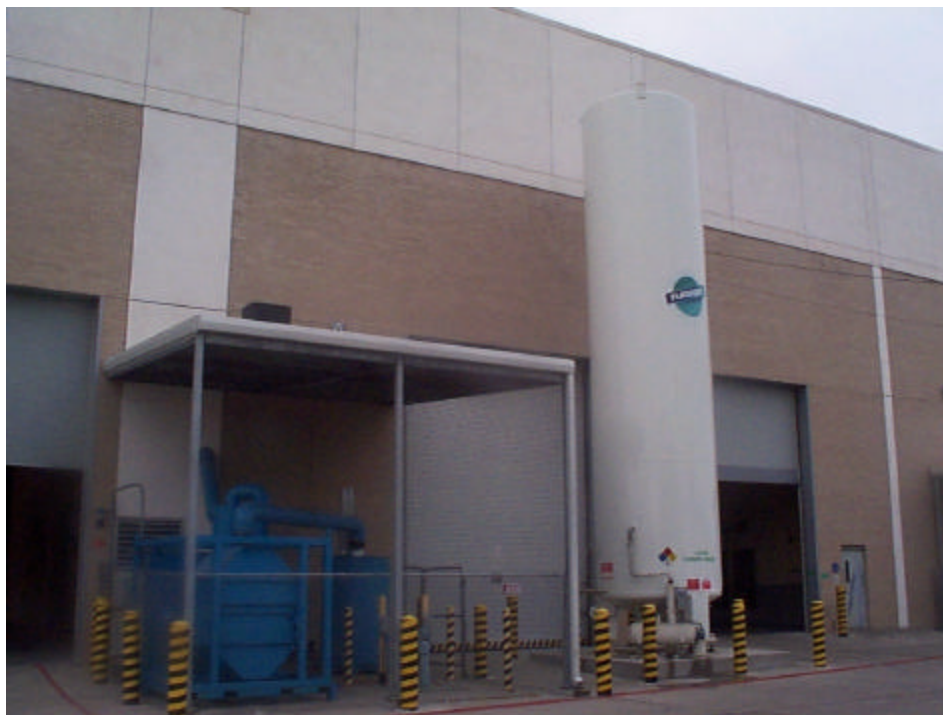
Figure 2: Effluent Capture System With CO<sub>2</sub> Tank

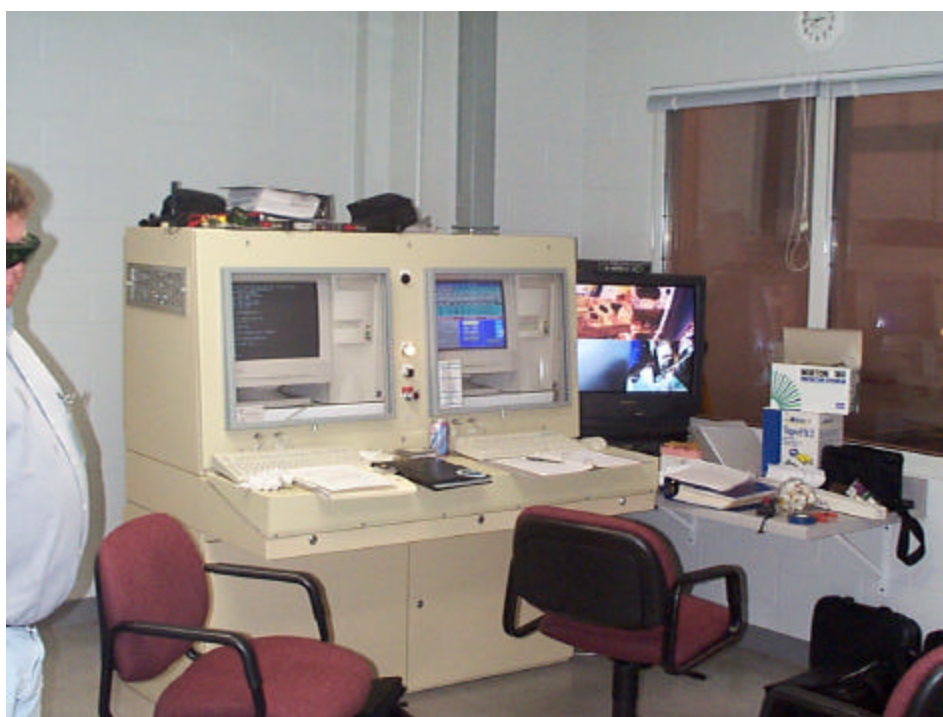
Figure 3: Computer Processing Cell Controller

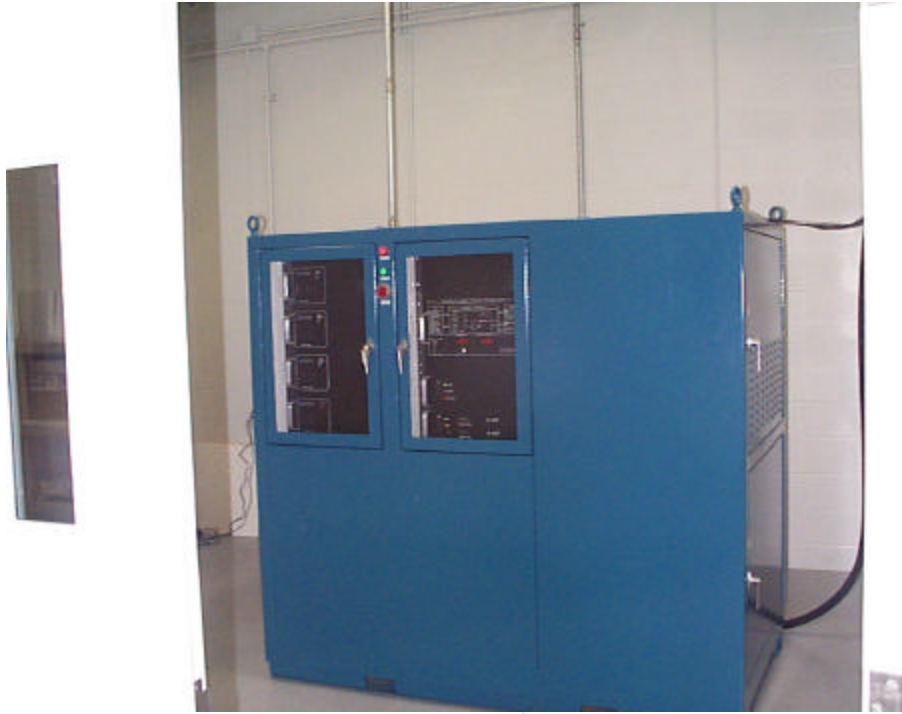
Figure 4: FLASHJET<sup>®</sup> Power Supply

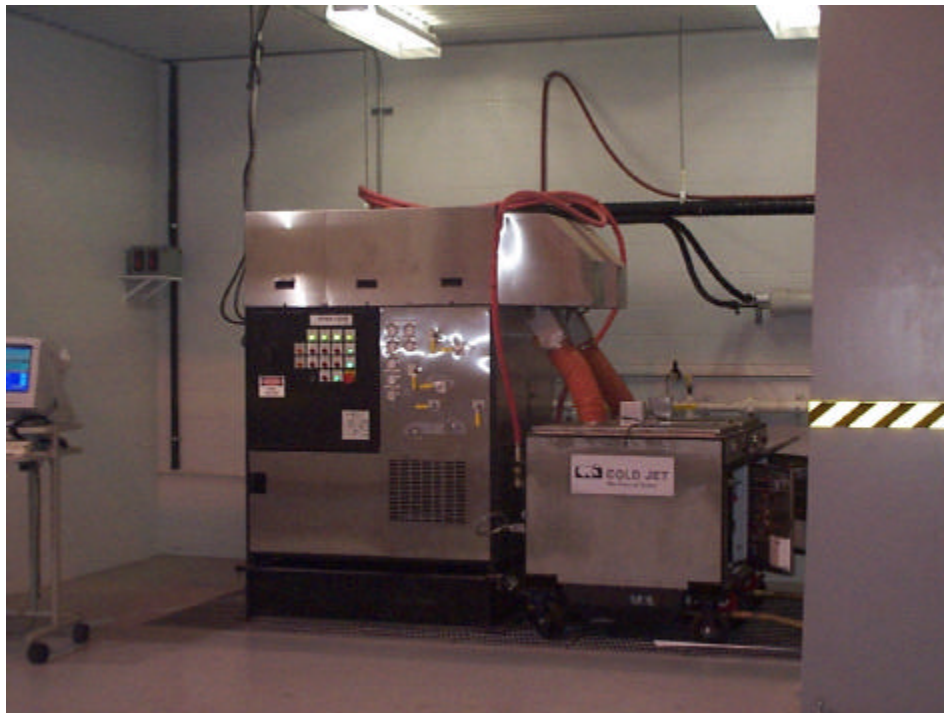
Figure 5: CO<sub>2</sub> Pelletizer

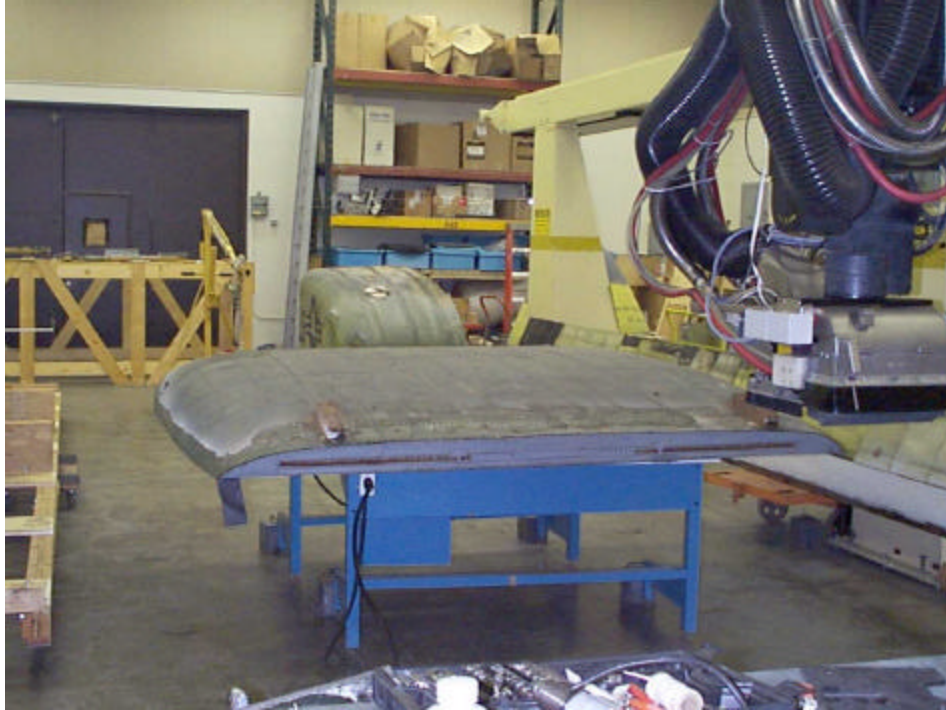
Figure 6: CH-53 Cargo Ramp Prior To Stripping

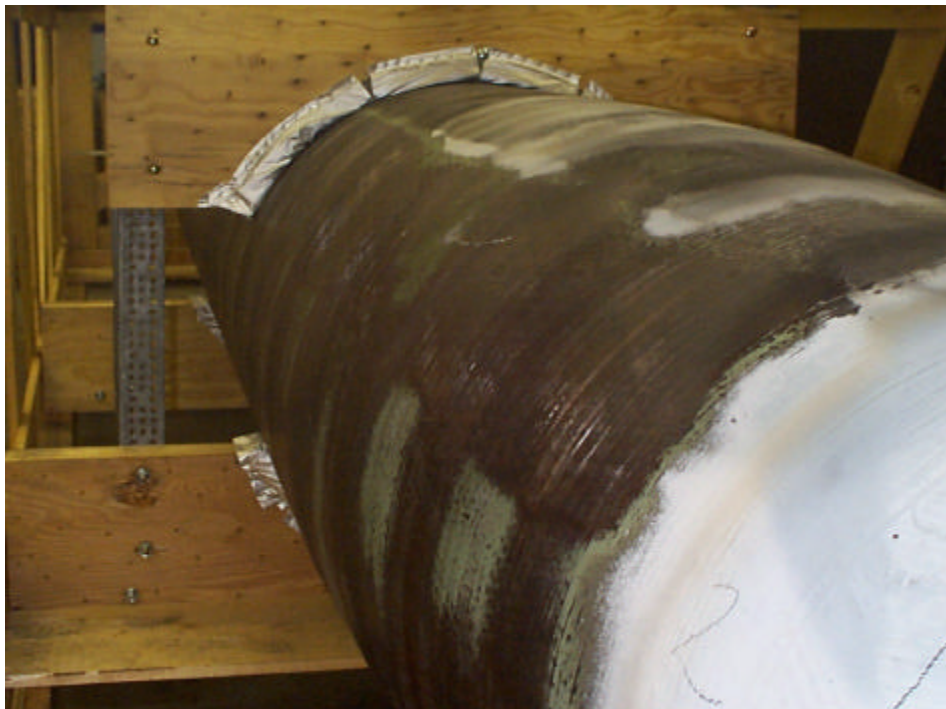
Figure 7: CH-53 Auxiliary Fuel Tank After Stripping

In accordance with Section 3.1.1 of the JTP, all stripped sections were visually inspected to determine if the FLASHJET<sup>®</sup> process caused any physical damage to the substrates. Seven off-aircraft components were evaluated in this phase of testing including the cargo ramp, cargo door, auxiliary fuel tank, pylon, main rotor blade (Titanium), upper personnel door, and lower personnel door. All seven off-aircraft components were visually inspected and no damage to the stripped substrates was found.

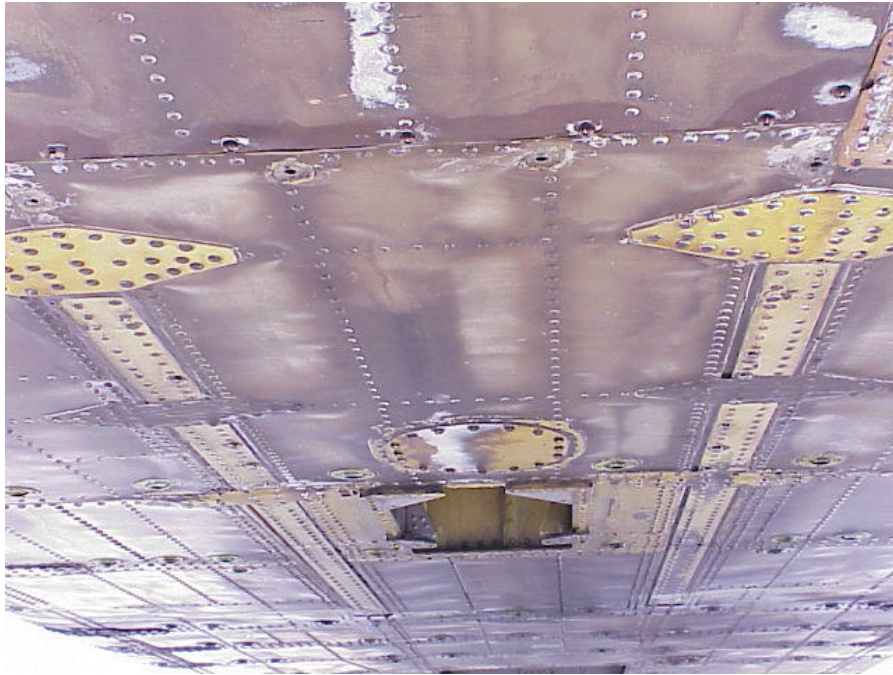
Figure 8: SH-60 Belly Of Aircraft After Stripping

In accordance with Section 3.1.1 of the JTP, all sections of the SH-60 were visually inspected for possible substrate damage caused by the FLASHJET® process. One section of the aircraft was found to have substrate damage potentially caused by excessive heat buildup. On the back of this section, there was “bondo” like material which possibly caused the panel to heat up. Fortunately this panel was not flight critical and was replaced. After the panel was replaced, the aircraft was re-inspected and no further problems were found.

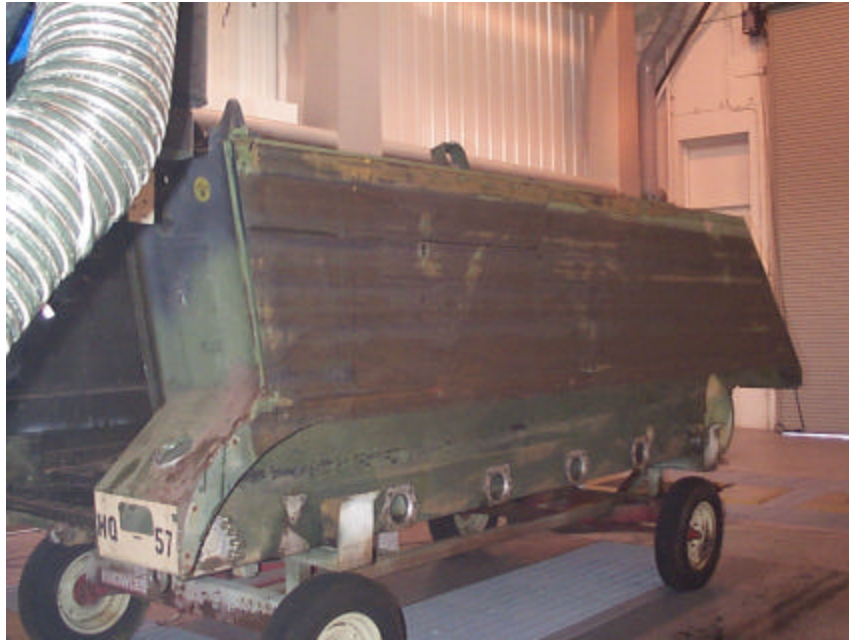
Figure 10: Side Of M113 After Stripping

Section 3.1.2 of the JTP specified for only topcoat removal with no damage to the underlying primer. The two sides of the M113 APC were visually evaluated against this acceptance criteria. Both sections were stripped cleanly to the primer and showed no signs of damage to the underlying primer. The acceptance criteria for Section 3.1.2 was met.

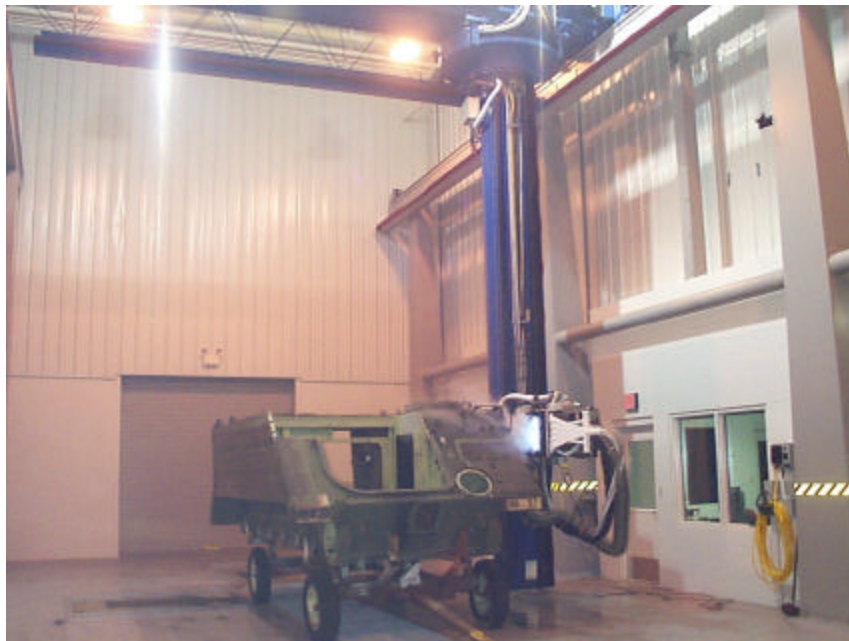
Figure 11: M113 Side During Stripping Operation
